**DEPARTMENT OF TRANSPORTATION**

Contract #: 04-0120F4Cty: SF/ALA Rte: 80 PM: 13.2/13.9File #: 69.28**WELDING INSPECTION REPORT****Resident Engineer:**Pursell, Gary**Address:** 333 Burma Road**City:** Oakland, CA 94607**Report No:** WIR-015508**Date Inspected:** 09-Jul-2010**Project Name:** SAS Superstructure**OSM Arrival Time:** 700**Prime Contractor:** American Bridge/Fluor Enterprises, a JV**OSM Departure Time:** 1900**Contractor:** Zhenhua Port Machinery Company, Ltd (ZPMC), Changxing Island **Location:** Shanghai, China**CWI Name:** Chen Xi.**CWI Present:** Yes No**Inspected CWI report:** Yes No N/A**Rod Oven in Use:** Yes No N/A**Electrode to specification:** Yes No N/A**Weld Procedures Followed:** Yes No N/A**Qualified Welders:** Yes No N/A**Verified Joint Fit-up:** Yes No N/A**Approved Drawings:** Yes No N/A**Approved WPS:** Yes No N/A**Delayed / Cancelled:** Yes No N/A**Bridge No:** 34-0006**Component:** OBG**Summary of Items Observed:**

## WELDING INSPECTION REPORT

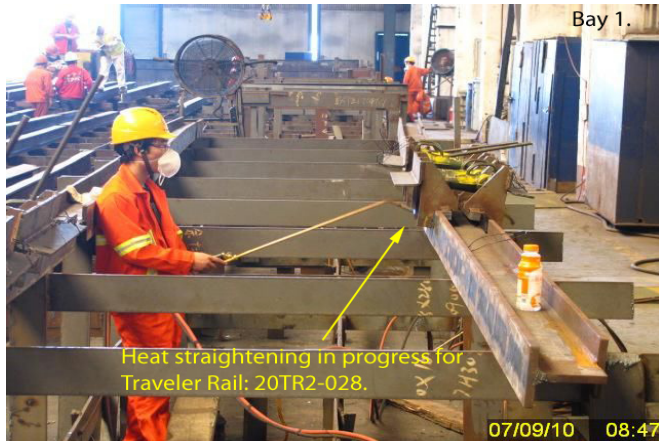
Heat straightening of OBG component – Traveler Rail; weld joint: 20TR2-028. Heat straightening was done as per Heat Straightening Record (HSR): HSR (B)-362 Rev-1 Dt: 04/18/10. ZPMC QC is identified as Ai Wei. Heat straightening was done to correct the distortion due to welding.

Photo attached for reference.

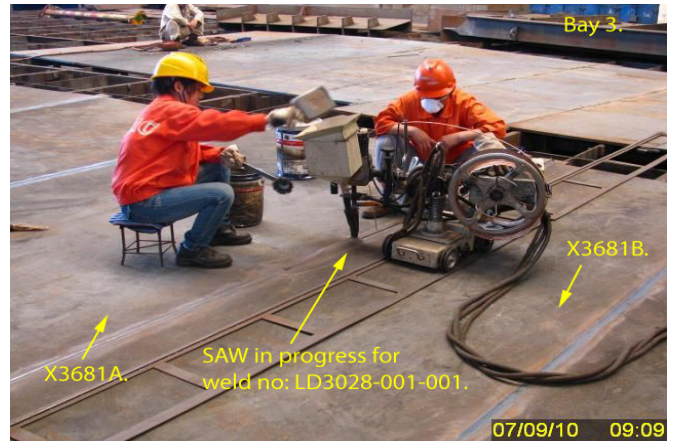
Submerged Arc Welding (SAW) of OBG component – Longitudinal Diaphragm; weld joint LD3028-001-001. Welder is identified as 058100. ZPMC QC is identified as Wang Liang. The welding variables recorded by QC appeared to comply with the Applicable WPS: B-T-2221-B-L2c-S-2.  
Photo attached for reference.
